In The Swim

EPOTEC
THE Proven Hi Build Pool Coating

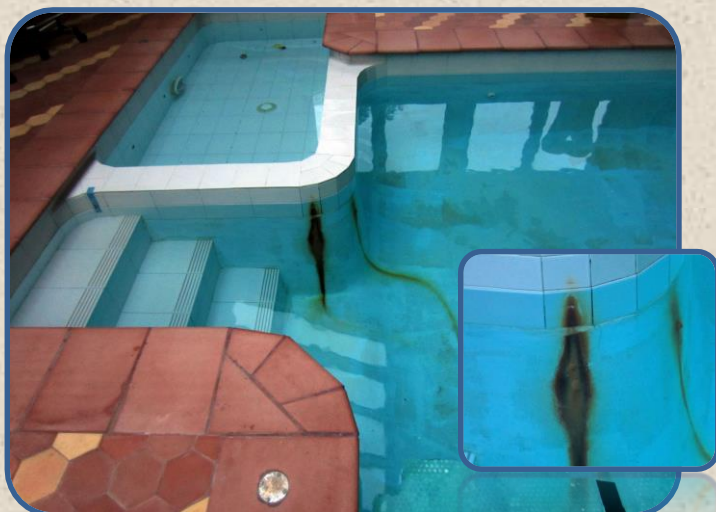
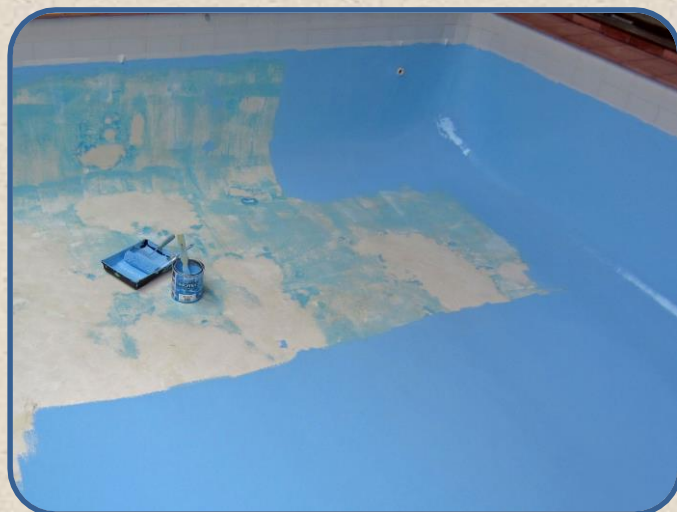
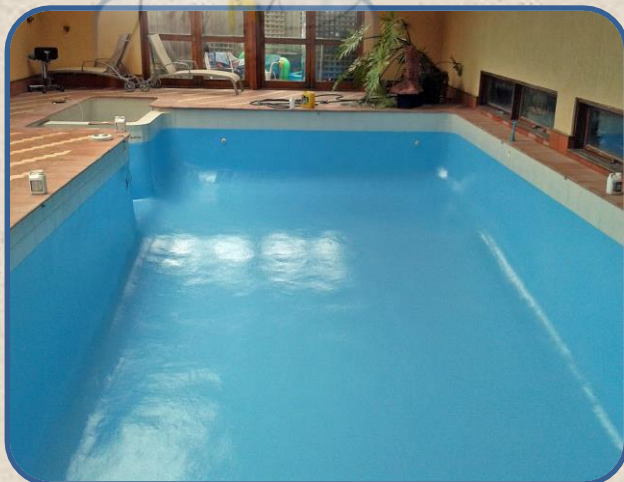
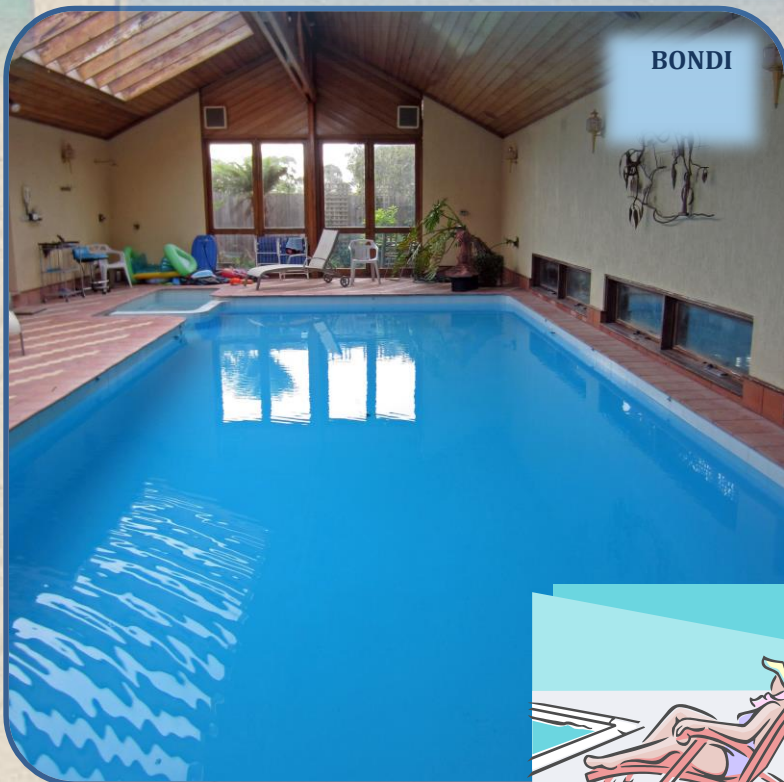
Black Rock Pool in Bondi

A family indoor pool has provided years of enjoyment, but was now in need of a revamp. There were issues to do with corroding reo steel, with resultant rust stains and worn paint, making for an unattractive pool all through.

Peter, the owner got to work practising his “dentistry” skills, removing weakened concrete down to the rotten steel, cutting that out, treating the remainder and re filling the cavities. It was followed by a thorough clean.

There after 2 coats of Epotec, in the Bondi colour were applied to give a great cool blue result.

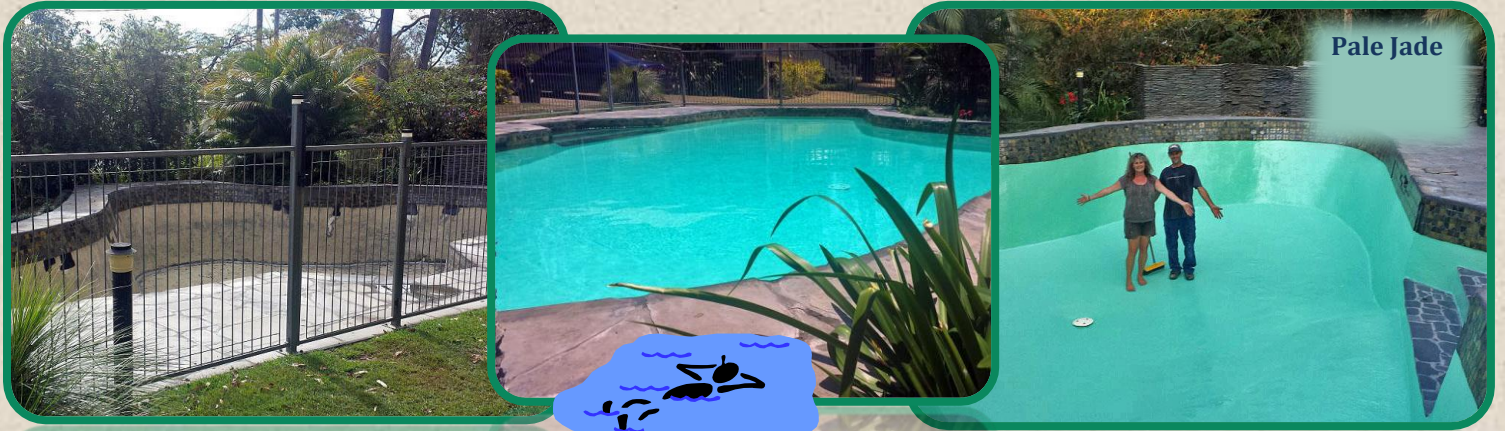
Kylie's new pale jade pool

We started with a concrete pool which had originally been charcoal but had faded over the years, and the pool walls had quite a few repair patches.

Myself and a friend prepared the surface, put up tarps and painted the pool (Epotec Pale Jade) following the Epotec instructions provided by Hitchins Technologies.

The result is fantastic, it almost looks like a new pool, as I had before. Cleaning has been a lot easier too. I have a mechanical pool cleaner most of the time but if the pool requires manual vacuuming the vacuum glides over the new Epotec surface easily. And with the lighter colour pool surface I can see any leaves or dirt on the bottom which means I don't need to manually vacuum the whole pool as I did before.

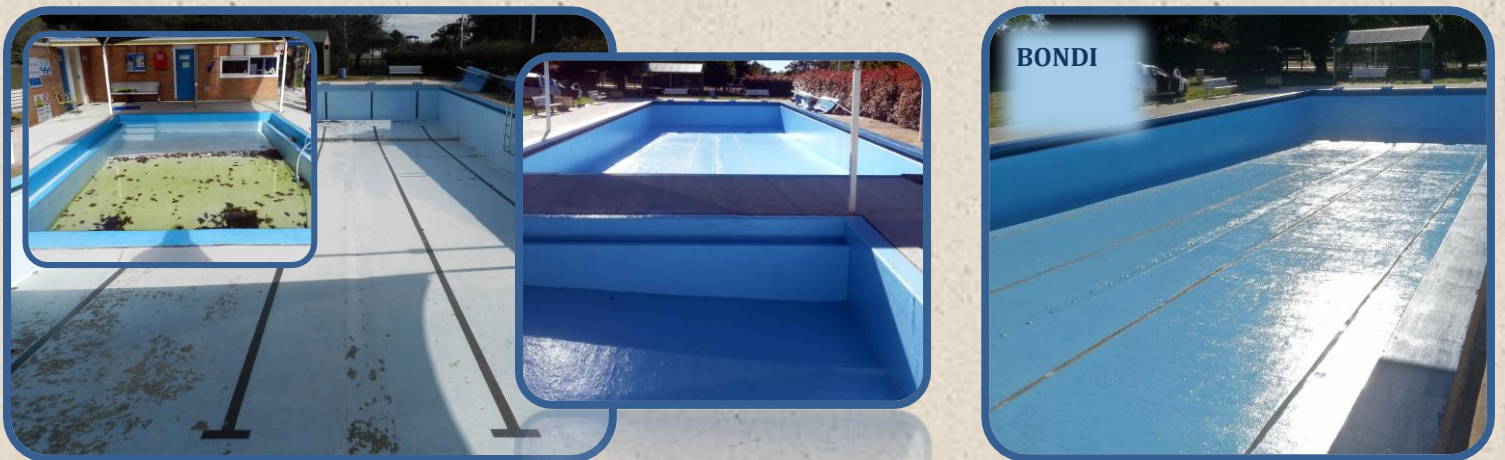
Recoating Bundanoon Council Pool

Recently the Wingecarribee Shire Council in the NSW Southern Highlands, engaged one of Hitchins Technologies approved applicators to carry out the repair and re coating of their 25 M outdoor pool.

The work undertaken included abrasive blasting the old worn chlorinated rubber coating off, removal of the failed jointing systems and de facing the tiles at the 2 end walls. The jointing system was repaired with Drizoro Maxjoint elastic, surface cracks repaired with Maxrest and the deep cavities with Maxplug. Large cracks in the old concrete were cut out and filled using Maxplug and a finishing coat of MaxSeal.

The defaced tiles were primed with RLA Primer and then over coated with RLA Just 2 ezy, to provide a smooth surface. The primer and cement adhesive were also used extensively on the pools inner surfaces to even out pitting from abrasive blasting and normal wear and tear for an old concrete pool.

All pool surfaces then were coated with 2 coats of Epotec hi build epoxy coating in colour, Bondi. Black lines in Epotec were also applied. Epotec in the dark blue Pacific was applied to the gutters.

An adjoining fibreglass lined toddler pool also got the Epotec treatment, but with a non-slip finish on the steps.
